ADDITIONAL LESSONS FROM SATELLITE IMAGERY AND INVESTIGATION OF BIRCH AND ITS BREAKAGE

Chris J Cieszewski

2. NEW DEVELOPMENTS

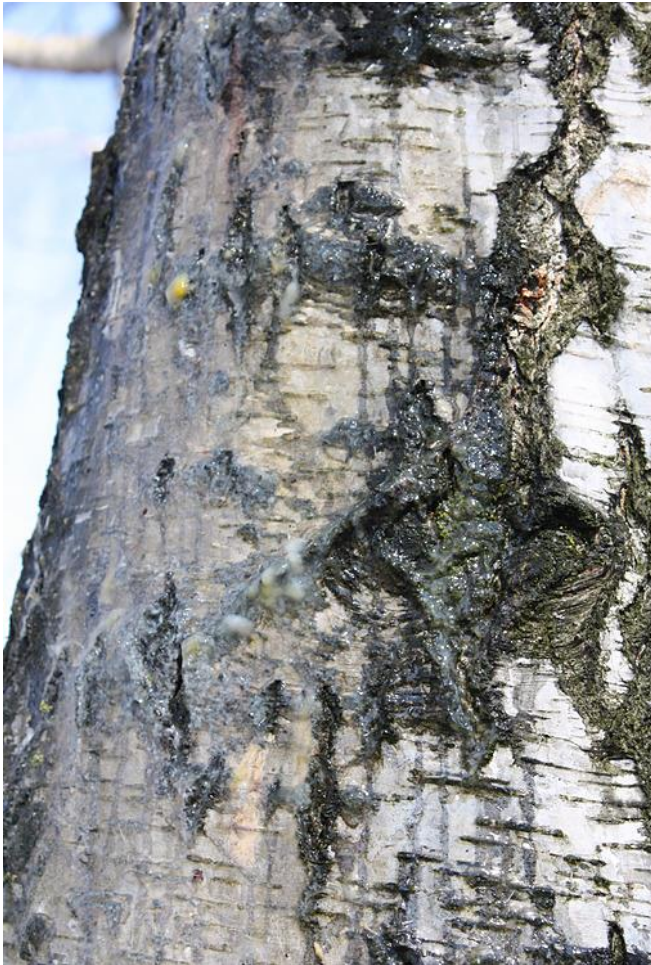
Fig. 1. Examples of birch (*betula pendula*) bleeding sap from a broken branch.

For example, the blogger 3zet conducted a series of empirical experiments with various damages to silver birch (*betula pendula*) trees, documented with many hundreds (perhaps even thousands) of pictures demonstrating the behavior of this species in the presence of various damages made at the end of Winter season, which demonstrated abundance of sap bleedings caused by any kind of damage to cambium, such as scaring the bark, trunk cracks, damaged and cut branches, broken tree stumps (Fig. 1), wind brakes (

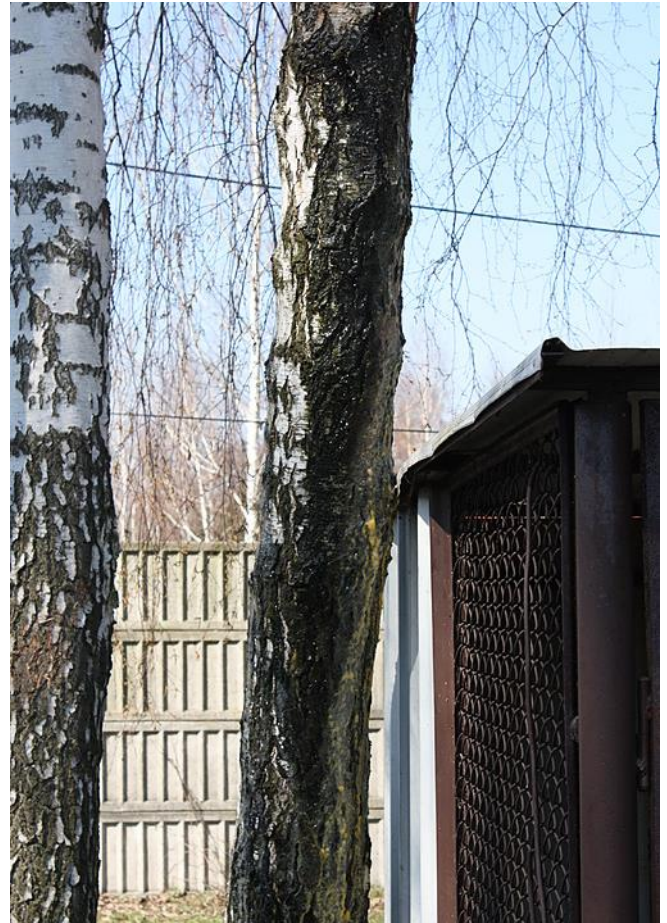
Fig. 2. Birch (*betula pendula*) heavily bleeding sap from tree brake.

Fig. 2) and various other experiments. With no exception all birch trees damaged at the beginning of Spring produced abundant quantities of birch sap, even at the time of apparent frost when the seeping out sap was getting frozen on tree stumps. Even trees damaged shortly before the beginning of the Spring season and frozen at the time of bleeding (Fig. 3), continue bleeding as soon as they defrost as long as the open cells don't get shrank and closed by the drying process, which depending on air moisture and temperature may take between several days to a few months.

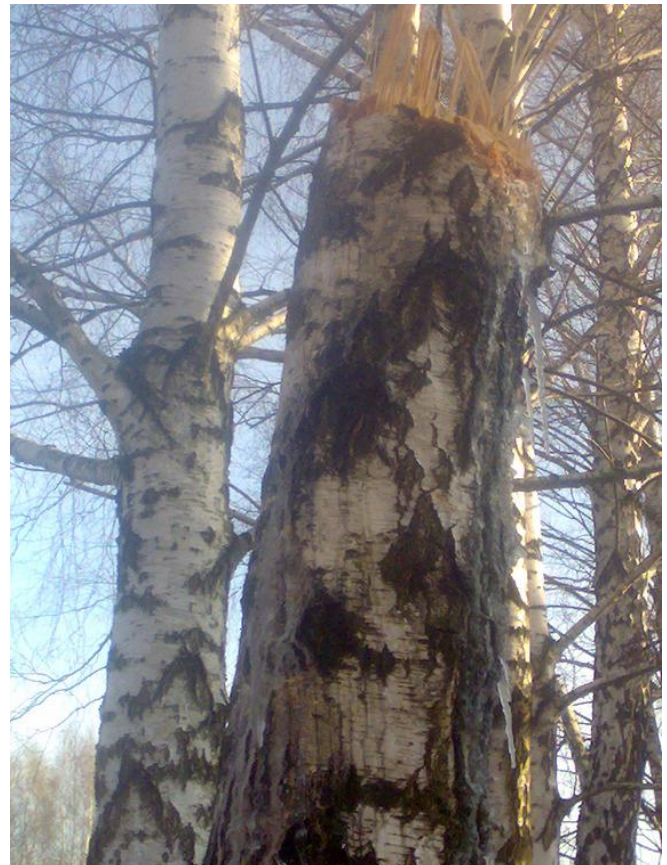
Fig. 3. Frozen sap on a broken birch (*betula pendula*) during early Spring.

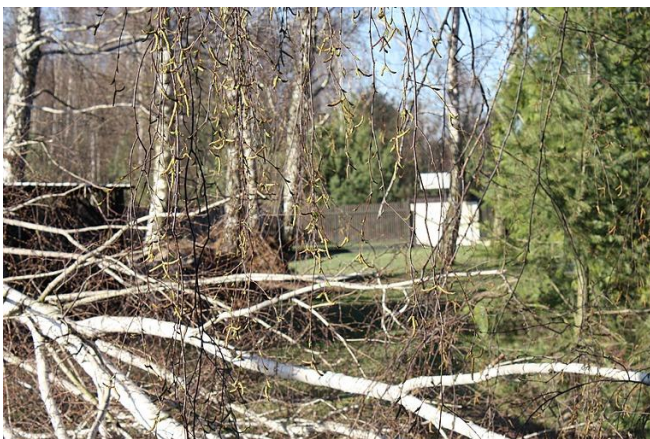
Fig. 4. Treetop cut before the vegetation season (left) some days later continues developing leaves on the ground (right).

demonstrating the expected normal development of leaves and flowers on the cut off treetops and branches (Fig. 4). Among other analysis of the available photographs from the Smolensk crash incident related to the alleged TU-154M-101 collision with the birch it's worth to bring up the observations of doradcar305 regarding the embedded in the tree metal parts with highly weathered and oxidized surfaces, appearance of which did not match at all the appearance of the aircraft parts and debris. Furthermore, the alleged wood shavings in the broken aircraft wing parts consisting of regular saw shavings, which are highly suspect to claim that they could have originated from the contact of the aircraft and the tree. These and the other discussed earlier anomalies and irregularities along with the indiscriminant and rather naive attitudes of the official Polish investigators and supporting them mainstream media beg the question if the misappearance of insincerity in the Polish government and the media is intentional or merely based on some kind of deeply rooted lack of interest in considering any counterarguments to the original official Russian report and an extreme ignorance. To answer this question we need to consider the reaction to the study the author presented on the second Smolensk Conference, which will be considered in the next section.

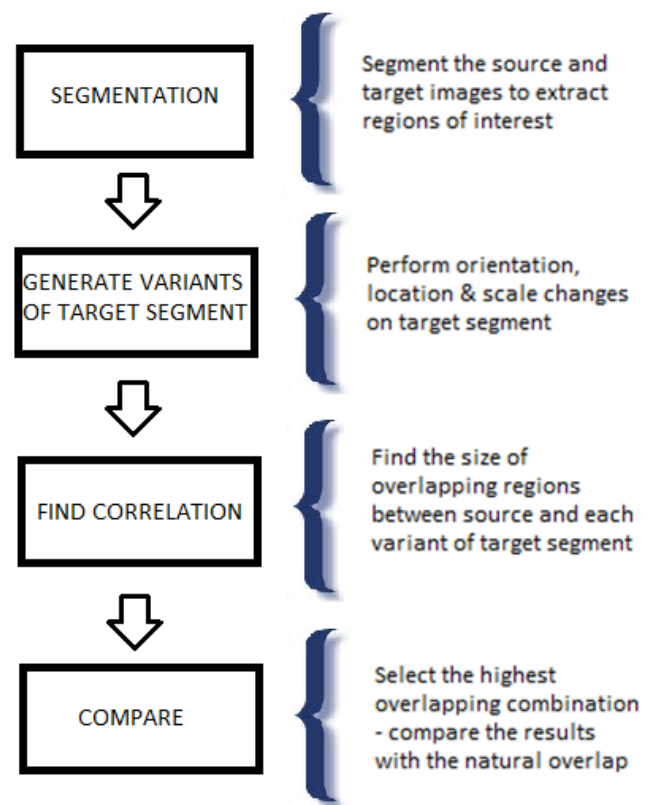
Fig. 5. Flowchart for the spatiotemporal correlation analysis determining the degree of coincidence in similarities of the polygons of white patches on Apr. 5, 2010, and the spatial distribution of the plain debris on Apr. 11, 2010.

- The analyses were conducted in four steps (Fig. 5).
- Segmentation – SLIC, Normalized Cuts.
- Generate variants – displacement up to 300% from center.
- Find the overlapping regions.
- Find the rate of overlap with the regions being displaced for 300 %..

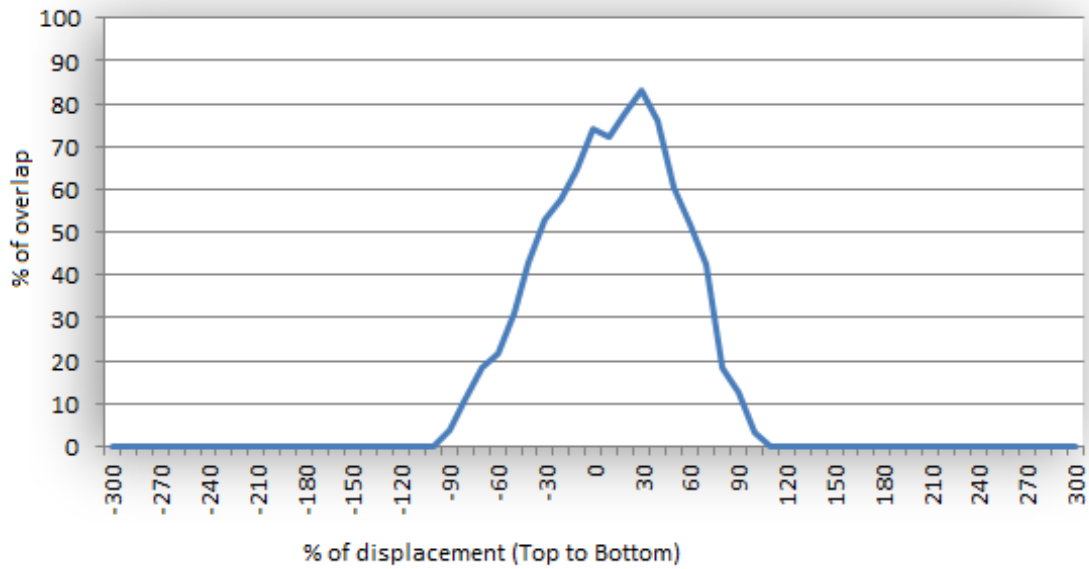
Fig. 6. Estimating the degree of coincidence by vertical displacement.

The results of the analysis are summarized in Fig. 6 and Fig. 7, and they indicate that by displacing the target region (flight crash region/Event 2) over the source region (white patches covered region/ Event 1) of the source image, either vertically or horizontally, the rate of overlap between the two different events is very high at a rate of about 75%, when compared to the overlap in other regions. In essence, these results mean that there is a strong likelihood that the crash in Smolensk at the given location was preceded by some explicit preparations on this very location, that might have, or might have not, been specifically intended for this purpose. For this reason that matter should be thoroughly investigated by the Polish and international Special Services.

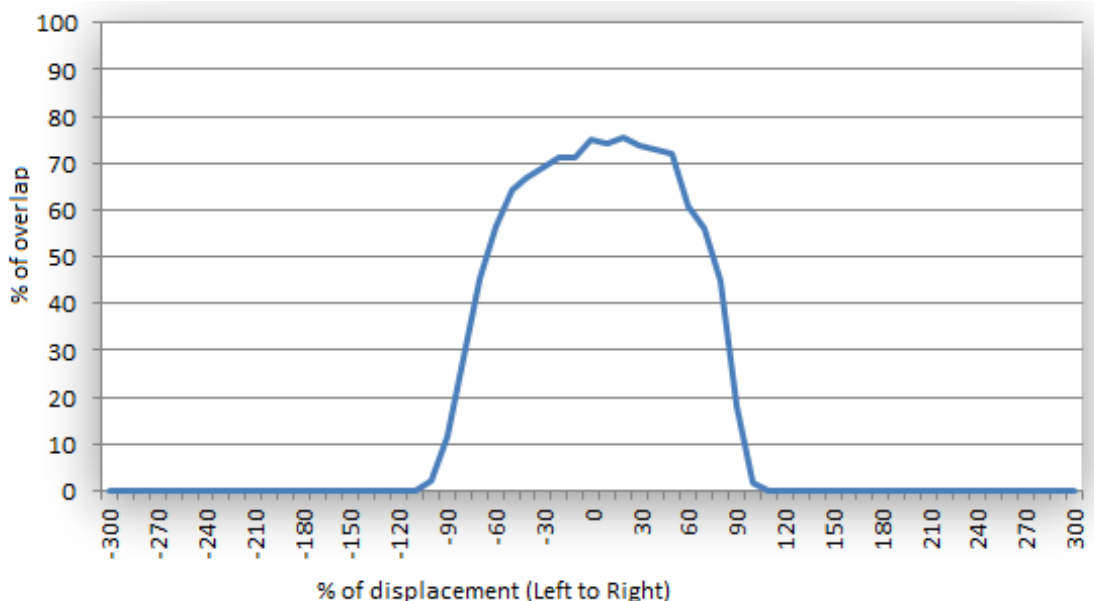
Fig. 7. Estimating the degree of coincidence by horizontal displacement.

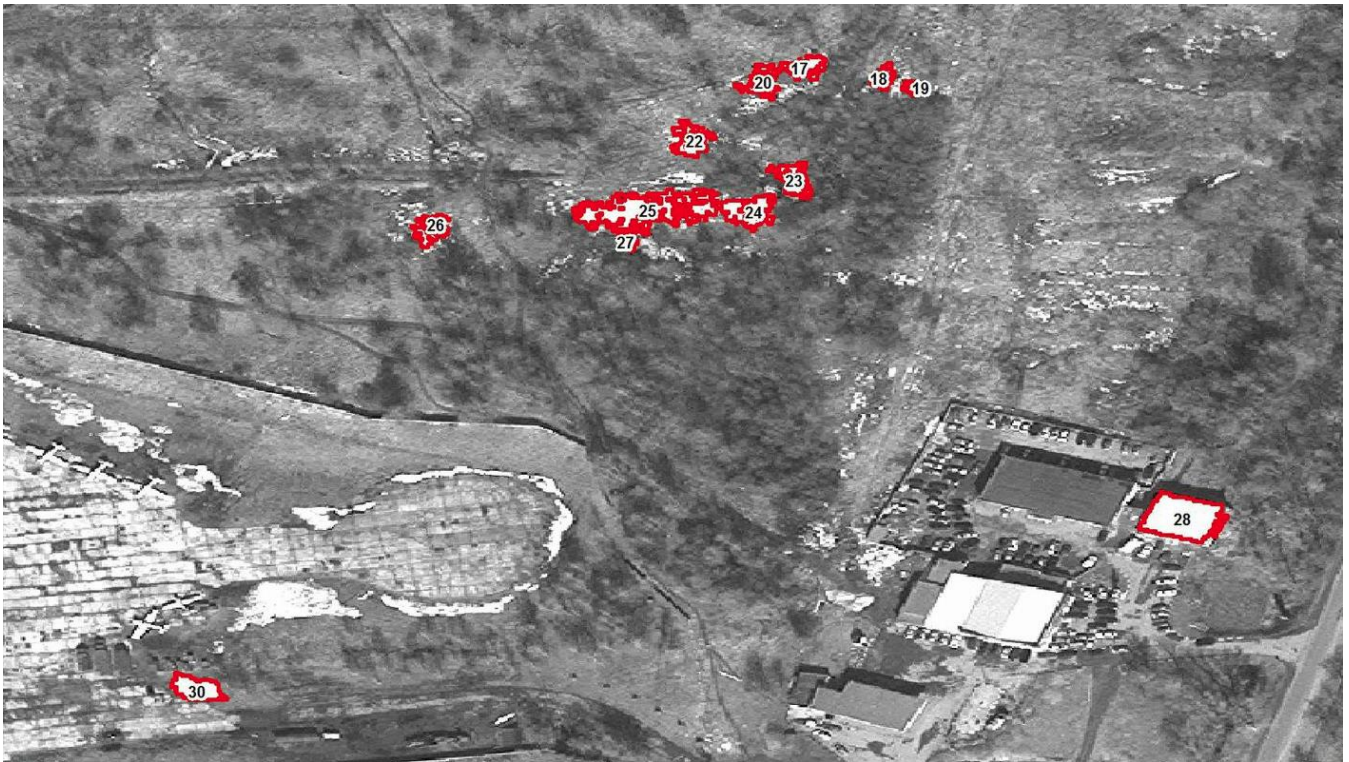
Fig. 9. Numbered patches are examples of the selected data locations: i) snowed up roof tops (e.g., 28); ii) Snow patches in the field (e.g., 17-20, 22, 27, 30); and iii) White patches on the crash site (e.g., 23-26).
